U. S. DEPARTMENT OF AGRICULTURE,
FOREST SERVICE—Circular 194.
HENRY S. GRAVES, Forester.

PROGRESS REPORT ON WOOD-PAVING EXPERIMENTS IN MINNEAPOLIS.

FRANCIS M. BOND,

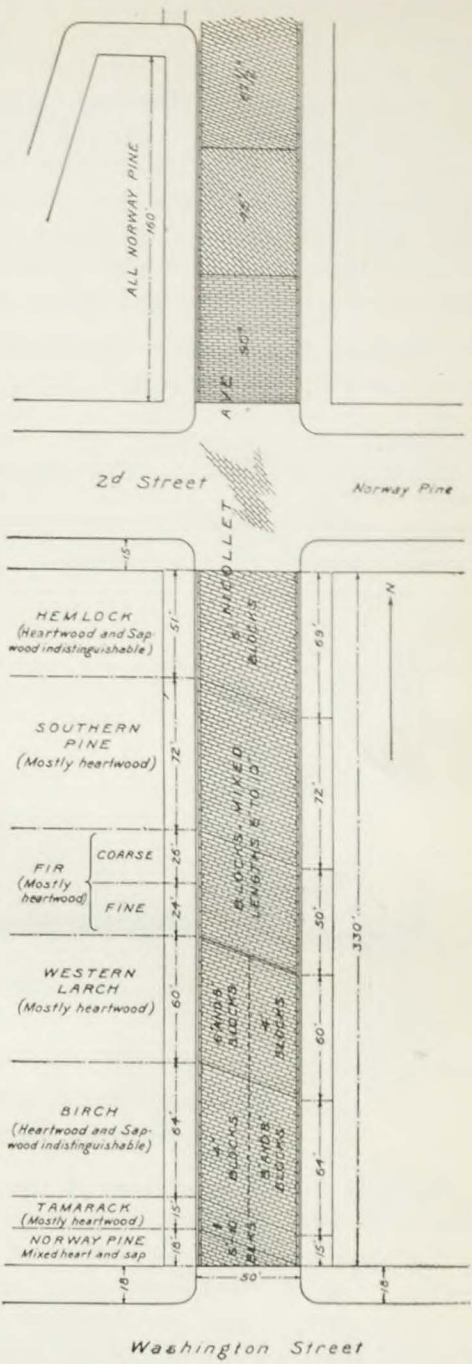
FIG. 1.—Experimental Creosoted Wood Block Pavement, Minneapolis, Minn.

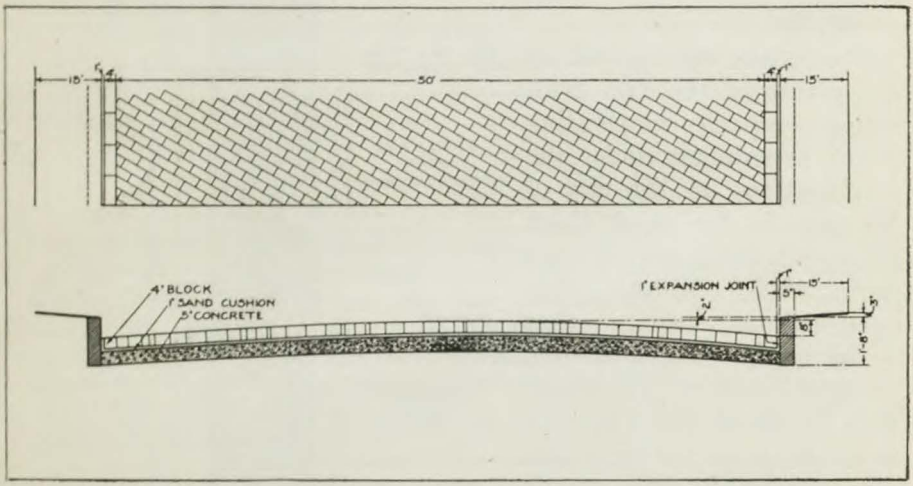
FIG. 2.—Construction of the experimental pavement.

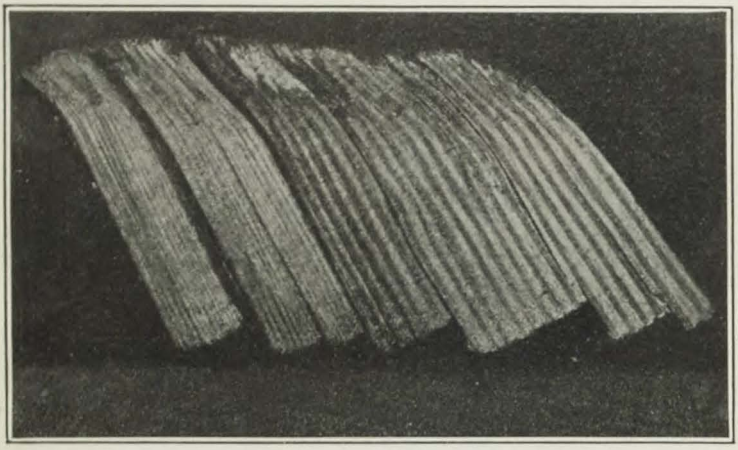
Sections 7 and 8 (coarse and medium grain Douglas fir) were so badly worn that the blocks had to be removed during the following

summer. The extreme depth of some of the depressions in the Douglas fir sections of the pavement requires some explanation, however, since the depth of depression does not in this case necessarily indicate the actual wear. Upon removal of several blocks from the lowest depressions it was found that the grain of the wood was no longer vertical but was inclined at a considerable angle, the blocks being separated into a number of pieces by longitudinal shear along the annual rings. This shearing and consequent inclination of the blocks must have taken place after the blocks had once become so reduced in depth by wear that their shearing strength could no longer resist the local tractive action to which they were subjected. The continual lessening of lateral support to the wood effected by wear and the continually increasing angle of inclination, of course, accelerated this action. The result is clearly shown in figure 3.

FIG. 3.—Badly worn Douglas fir paving block removed from a deep depression in the test pavement.

Since the Douglas fir was of rapid growth and poor grade, it is questionable whether the results of this test are a fair indication of its wearing qualities when used as a paving material.

At the beginning of the summer of 1911, nearly five years after the laying of the test pavement, the Douglas fir blocks were in such bad condition that it was necessary to remove them from the street and relay this portion of the pavement. Figure 4 shows the general condition along the central portion of the street just before the relaying of the Douglas fir sections. In one spot, comprising an area of about 30 square feet (not shown in the figure), the blocks were so badly worn that they were completely shattered into small bits.

In view of the poor quality of the original Douglas fir blocks, it was decided further to test this species by relaying one of the worn-out sections of the pavement with a thoroughly good grade of Douglas fir. Accordingly, a quantity of grade A Douglas fir paving stock was procured for this purpose. It was the intention to replace the second worn-out section with a good grade of jack pine, but so much difficulty was encountered in procuring the timber that the plan was abandoned. Douglas fir blocks were laid over as much of the area to be repaved as the quantity secured would cover, and the remaining part was paved with the regular southern yellow-pine blocks then in use by the city and furnished by it.[2] The Douglas fir was furnished

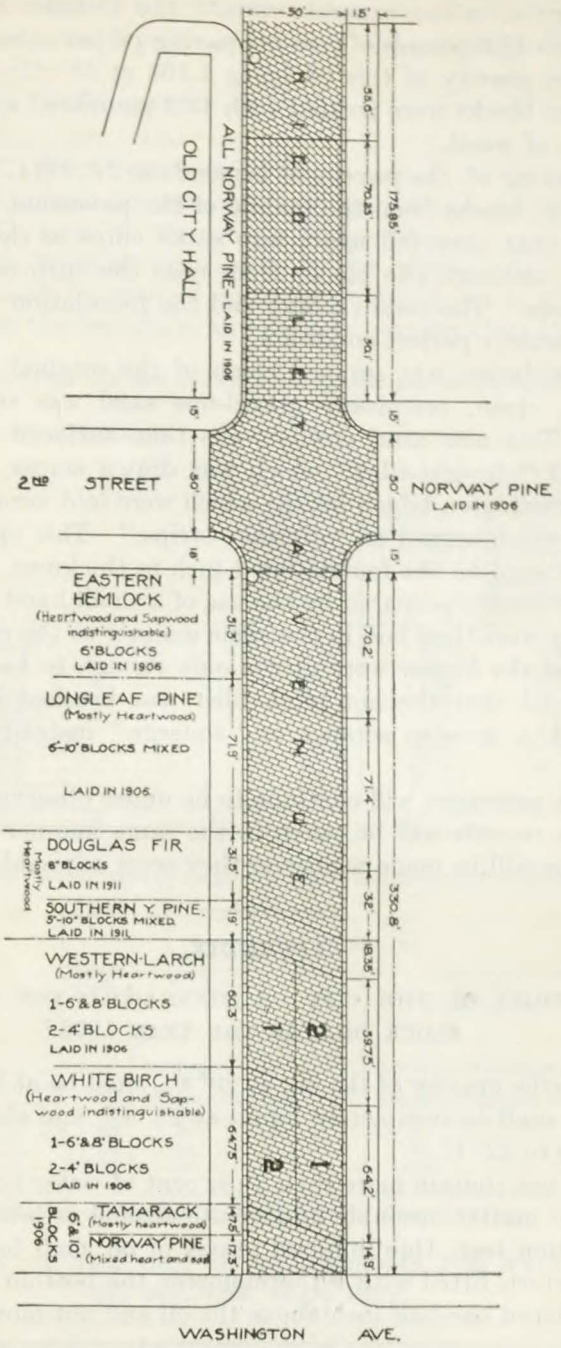
FIG. 5.—Arrangement of the experimental pavement laid in the summer of 1906; partially relaid June 27, 1911.

The relaying of the pavement began June 27, 1911. It was noted that the old blocks from the middle of the pavement were so badly shattered that they fell apart into small chips as they were being taken up, although the blocks from near the curb came out practically whole. The sand cushion and the foundation were found to be in apparently perfect condition.

The foundation was scraped clean of the original sand cushion, and fresh, clean, practically gravel-free sand was spread over its surface. This new sand cushion was then surfaced off by a long metal-shod "straight-edge" which was drawn across the street, its two ends resting on 1-inch boards which were laid across the foundation and which served as "distance strips." This operation left a cushion of sand on the foundation 1 inch in thickness, the surface of which was further prepared by the use of a small hand scraper. The new blocks were then laid in the same manner as the original blocks, except that the former were driven only enough to keep the courses straight, and that the hot pitch filler was brushed into the body joints with a wooden scraper or "squeege" instead of with steel brooms.
